FACILITY CONDITION ASSESSMENT

July 6, 2023

**WINDHAM ELEMENTARY SCHOOL - Main Building (PS347-U087)
5940 Windham Road
Windham , VT 05359**

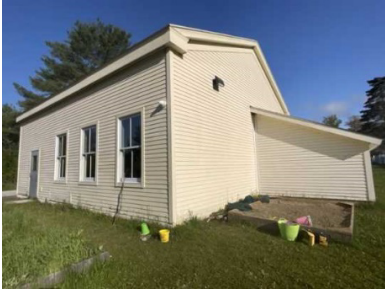
Exterior Walls in Poor condition.

any painted surface

Many areas around the school the paint is peeling and needs a fresh coat - AssetCALC ID: 6689496

Recommendation: **Prep & Paint in 2023**

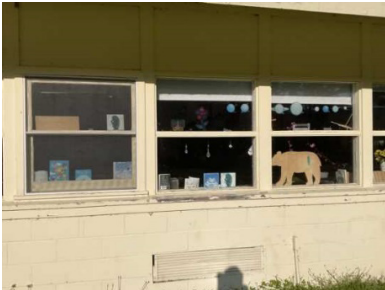
Window in Poor condition.

Wood, 16-25 SF

Single pane, very poor condition, rear of school - AssetCALC ID: 6689512

Recommendation: **Replace in 2023**

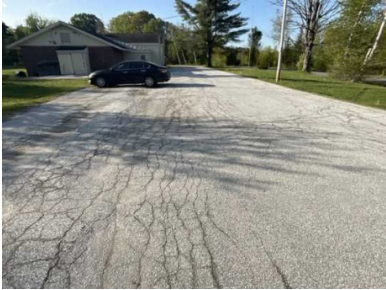
Parking Lots in Poor condition.

Pavement, Asphalt
WINDHAM ELEMENTARY SCHOOL - Main Building Site

Asphalt has alligator cracking and transverse cracking - AssetCALC ID: 6689527

Uniformat Code: G2020
Recommendation: **Mill & Overlay in 2023**
Priority Score: **84.9**
Plan Type: Performance/Integrity
Cost Estimate: \$54,300

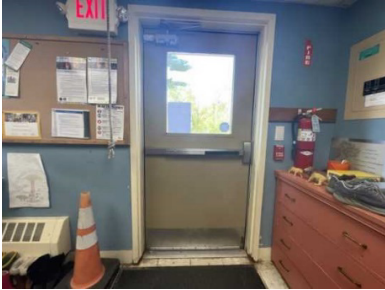
Exterior Door in Failed condition.

Steel, Standard
WINDHAM ELEMENTARY SCHOOL - Main Building Building Exterior

Door frame has rusted out next to floor. Needs replacement. - AssetCALC ID: 6689493

Uniformat Code: B2050
Recommendation: **Replace in 2023**
Priority Score: **81.9**
Plan Type: Performance/Integrity
Cost Estimate: \$600
\$\$\$\$

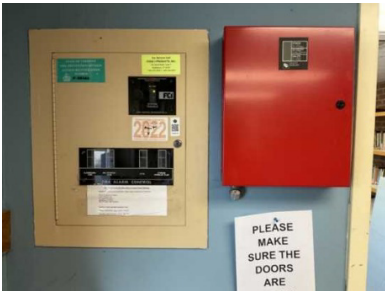
Fire Alarm Panel in Poor condition.

Multiplex
WINDHAM ELEMENTARY SCHOOL - Main Building Office

Fire alarm system has passed recommended useful life - AssetCALC ID: 6717899

Uniformat Code: D7050
Recommendation: **Replace in 2023**
Priority Score: **81.9**
Plan Type: Performance/Integrity
Cost Estimate: \$8,000
\$\$\$\$

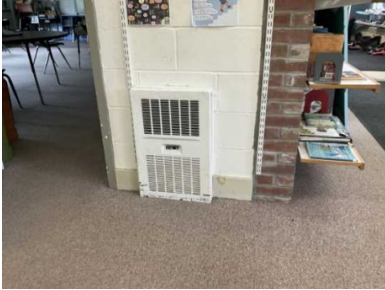
Fan Coil Unit in Poor condition.

Hydronic Terminal, 401 to 800 CFM
WINDHAM ELEMENTARY SCHOOL - Main Building Center section of school

Heater has passed, estimated useful life - AssetCALC ID: 6689504

Recommendation: **Replace in 2023**

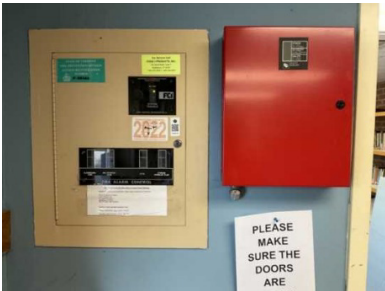
Fire Alarm System in Poor condition.

Full System Upgrade, Standard Addressable
WINDHAM ELEMENTARY SCHOOL - Main Building Throughout building

Fire alarm system has passed recommended useful life - AssetCALC ID: 6689521

Recommendation: **Upgrade/Install in 2023**

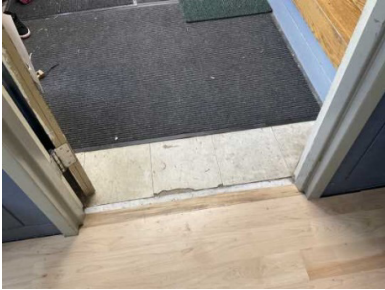
Flooring in Poor condition.

Vinyl Tile (VCT)
WINDHAM ELEMENTARY SCHOOL - Main Building Classrooms

Tile has passed, estimated useful life - AssetCALC ID: 6689507

Uniformat Code: C2030
Recommendation: **Replace in 2023**
Priority Score: **81.9**
Plan Type: Performance/Integrity
Cost Estimate: \$2,300
\$\$\$\$

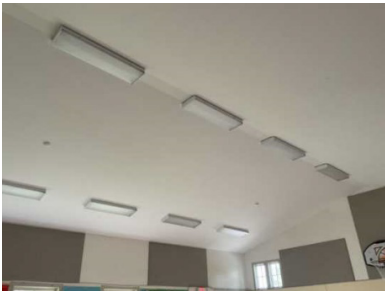
Interior Lighting System in Poor condition.

Full Upgrade, High Density & Standard Fixtures
WINDHAM ELEMENTARY SCHOOL - Main Building Throughout

Outdated - AssetCALC ID: 6689518

Uniformat Code: D5040
Recommendation: **Replace in 2023**
Priority Score: **81.9**
Plan Type: Performance/Integrity
Cost Estimate: \$21,000
\$\$\$\$

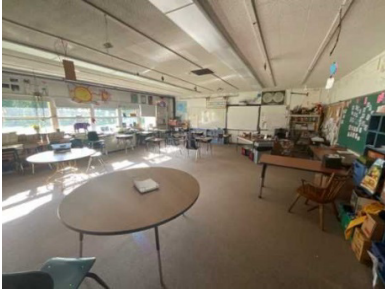
Flooring in Poor condition.

Carpet, Commercial Standard
WINDHAM ELEMENTARY SCHOOL - Main Building Throughout

Uniformat Code: C2030
Recommendation: **Replace in 2025**
Priority Score: **81.7**

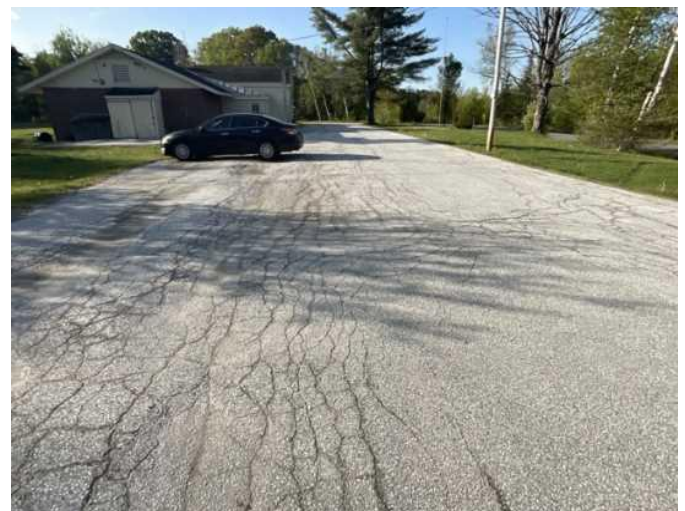
22 - PARKING LOTS

The asphalt pavement exhibits significant areas of failure and deterioration, such as alligator cracking, transverse cracking, extensive raveling, and heavy overall surface wear. All of the paving must be overlaid with new asphalt paving in order to maintain the integrity of the overall pavement system. Milling is recommended as part of the overall repair work. The playgrounds and sport fields are generally in good condition.
