UNITED STATES DEPARTMENT OF THE INTERIOR

Form Approved
OMB No. 42-R1765NATIONAL PARK SERVICE
Washington D.C. 20240HISTORIC PRESERVATION CERTIFICATION
APPLICATION—PART 1

1. Name of property: Chapman House
Address of property: Cornhill Road
City Windham County Windham State Vermont Zip Code 05359
Name of historic district in which property is located: Windham Historic District

**HISTORIC PRESERVATION CERTIFICATION
APPLICATION — PART 2**

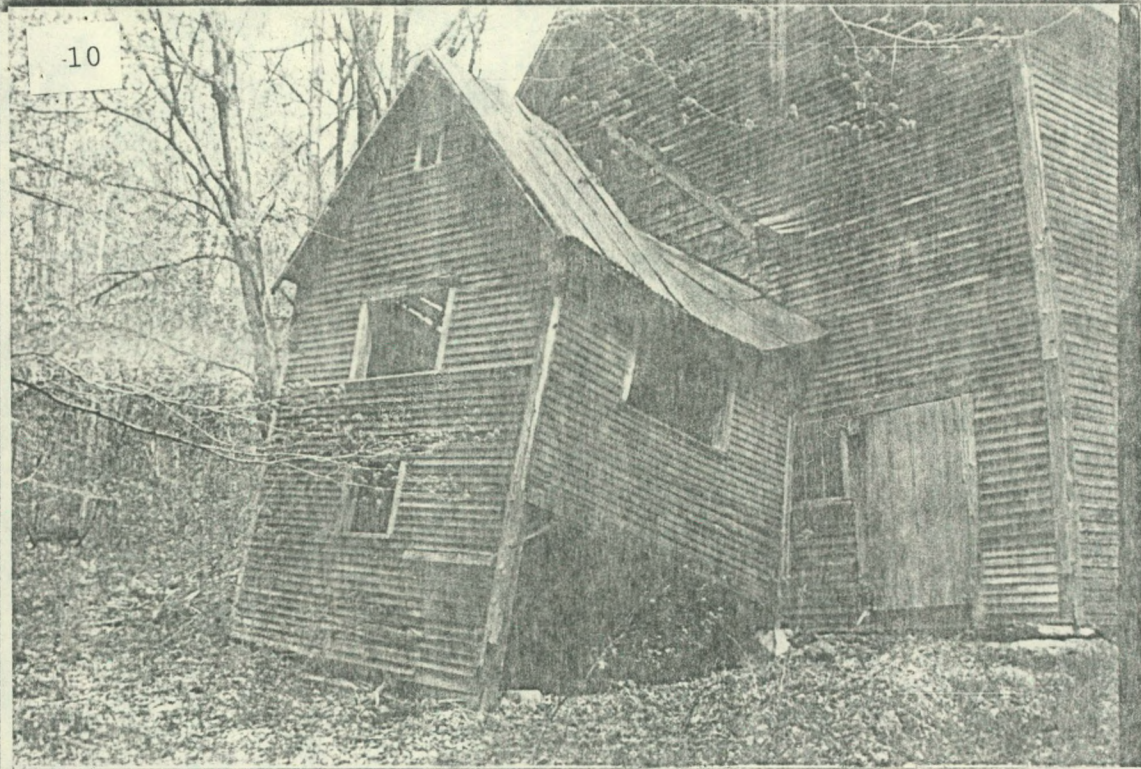
10.

Wood-frame chicken coop attached to south end of barn. Condition deteriorated and hazardous.

DATE: 5/83

SUBJECT: DETAIL

CHICKEN COOP

Repair of existing chicken coop to be explored. If not feasible, the building will be disassembled and stored in barn for later use.

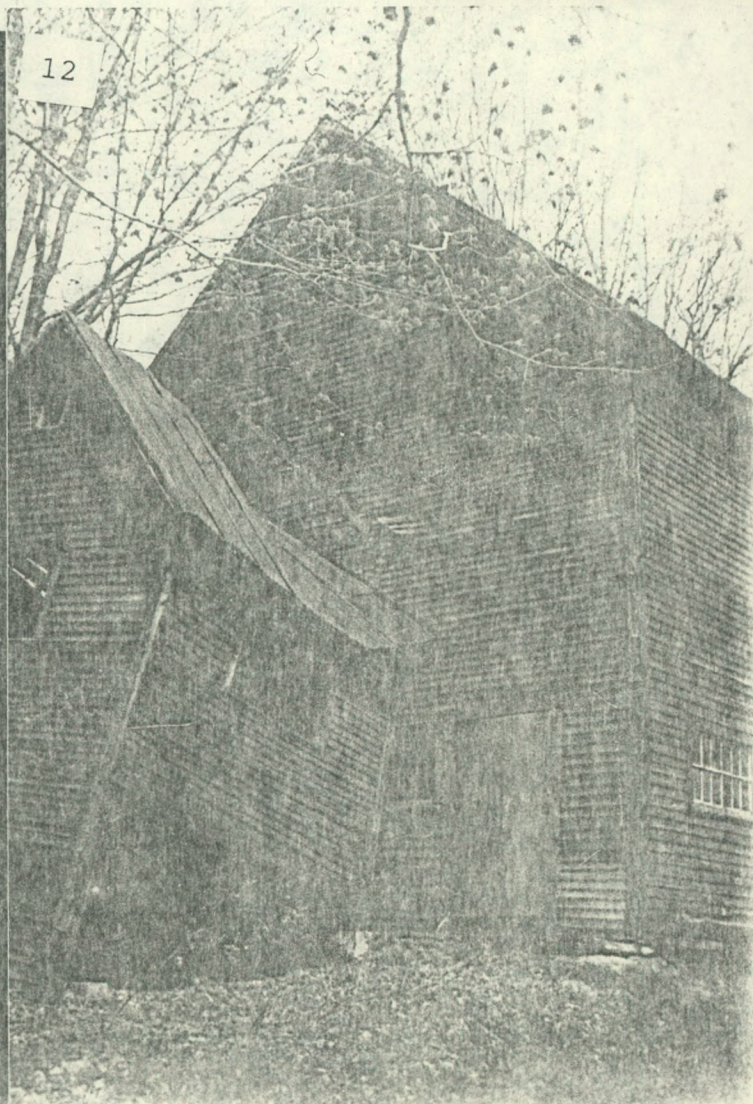
12

12.

DATE: 5/83

SUBJECT: CHICKEN

COOP

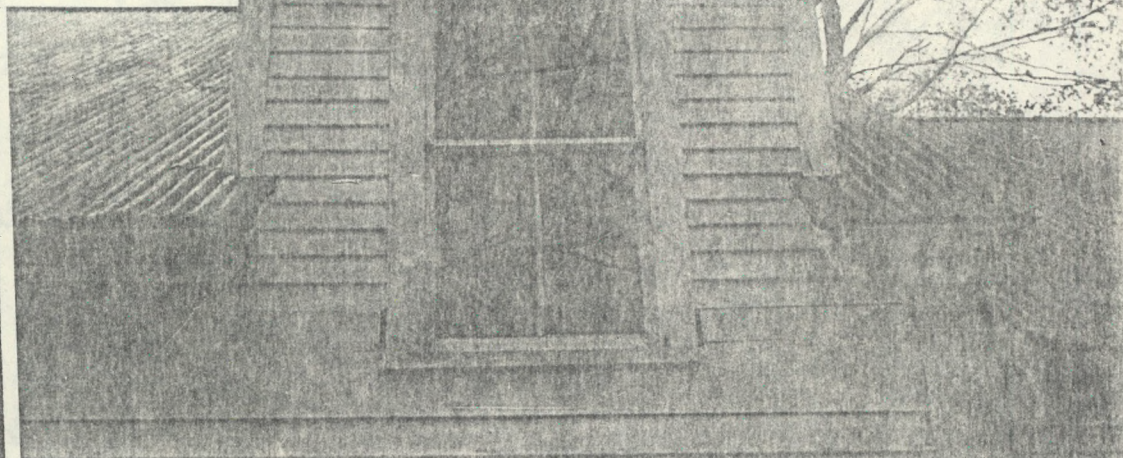
13

13. DATE: 5/83

SUBJECT: DORMER,
NORTH FACADE

Provide new septic system and bathroom and kitchen fixtures. Bathroom to be installed on landing (photo 32) beneath later dormer (photo 13). Fixtures to be simple and in keeping with historic character of house. Gypsum board wall with compatible new door to be installed. Elec. to meet modern standards.

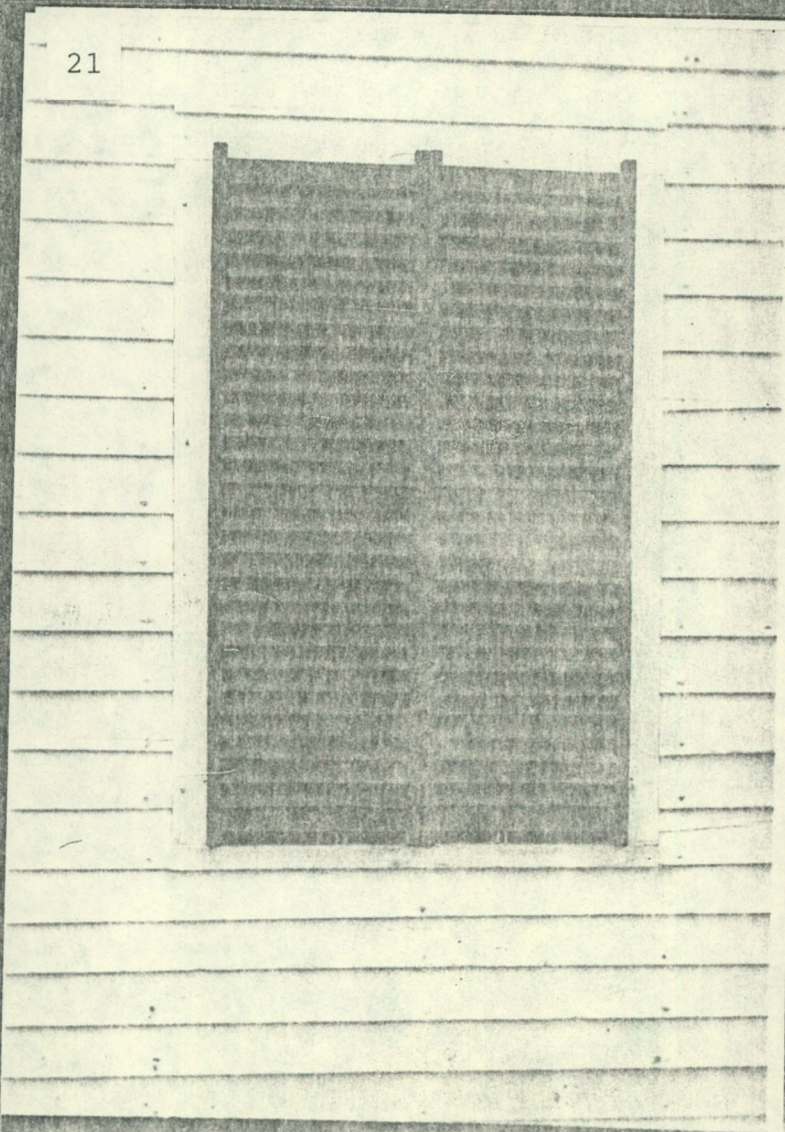
21

Wood shutters or exterior blinds with operable louvers. Deteriorated.

21.
DATE: 5/83
SUBJECT: SHUTTER
DETAIL - NO.
FACADE

Repair existing shutters. Scrape loose paint, apply linseed oil, putty, prime and repaint using good quality oil-based paint. Color, dark green as existing.
