South Windham Historic District  
Windham, Windham County, Vermont

**National Register of Historic Places  
Inventory—Nomination Form**

historic South Windham Village Historic District

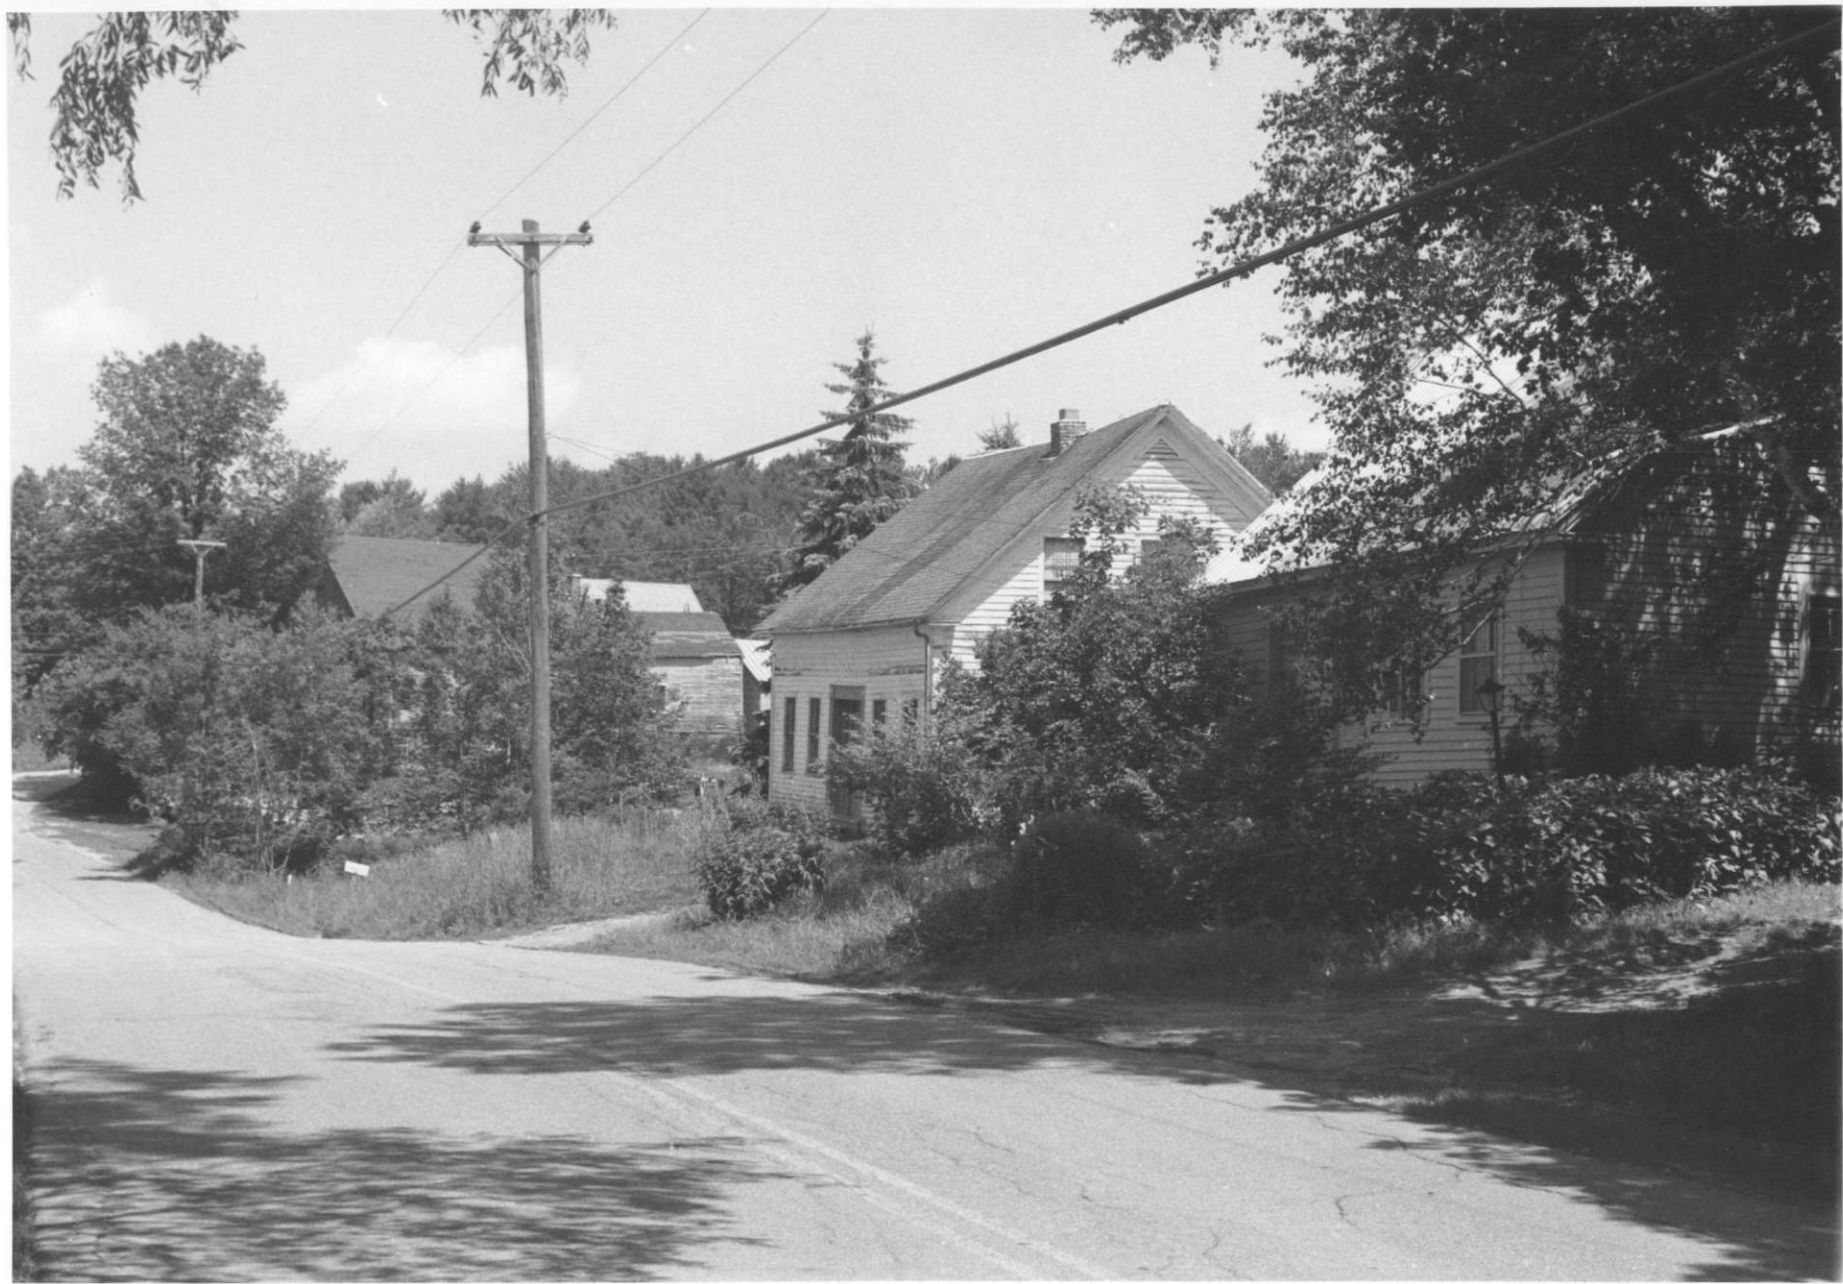
Photograph 4

South Windham Village Historic  
District  
Windham, Vermont  
Credit: David Tansey  
Date: July 1988  
Negative filed at Vermont Division  
for Historic Preservation  
Description: TH #1, Buildings #  
10, 11, 12 (left to right)  
View looking north.

10. The Worden House, c.1840.

11. The Fellows House, c.1840.

12. Holmes House, c.1835.

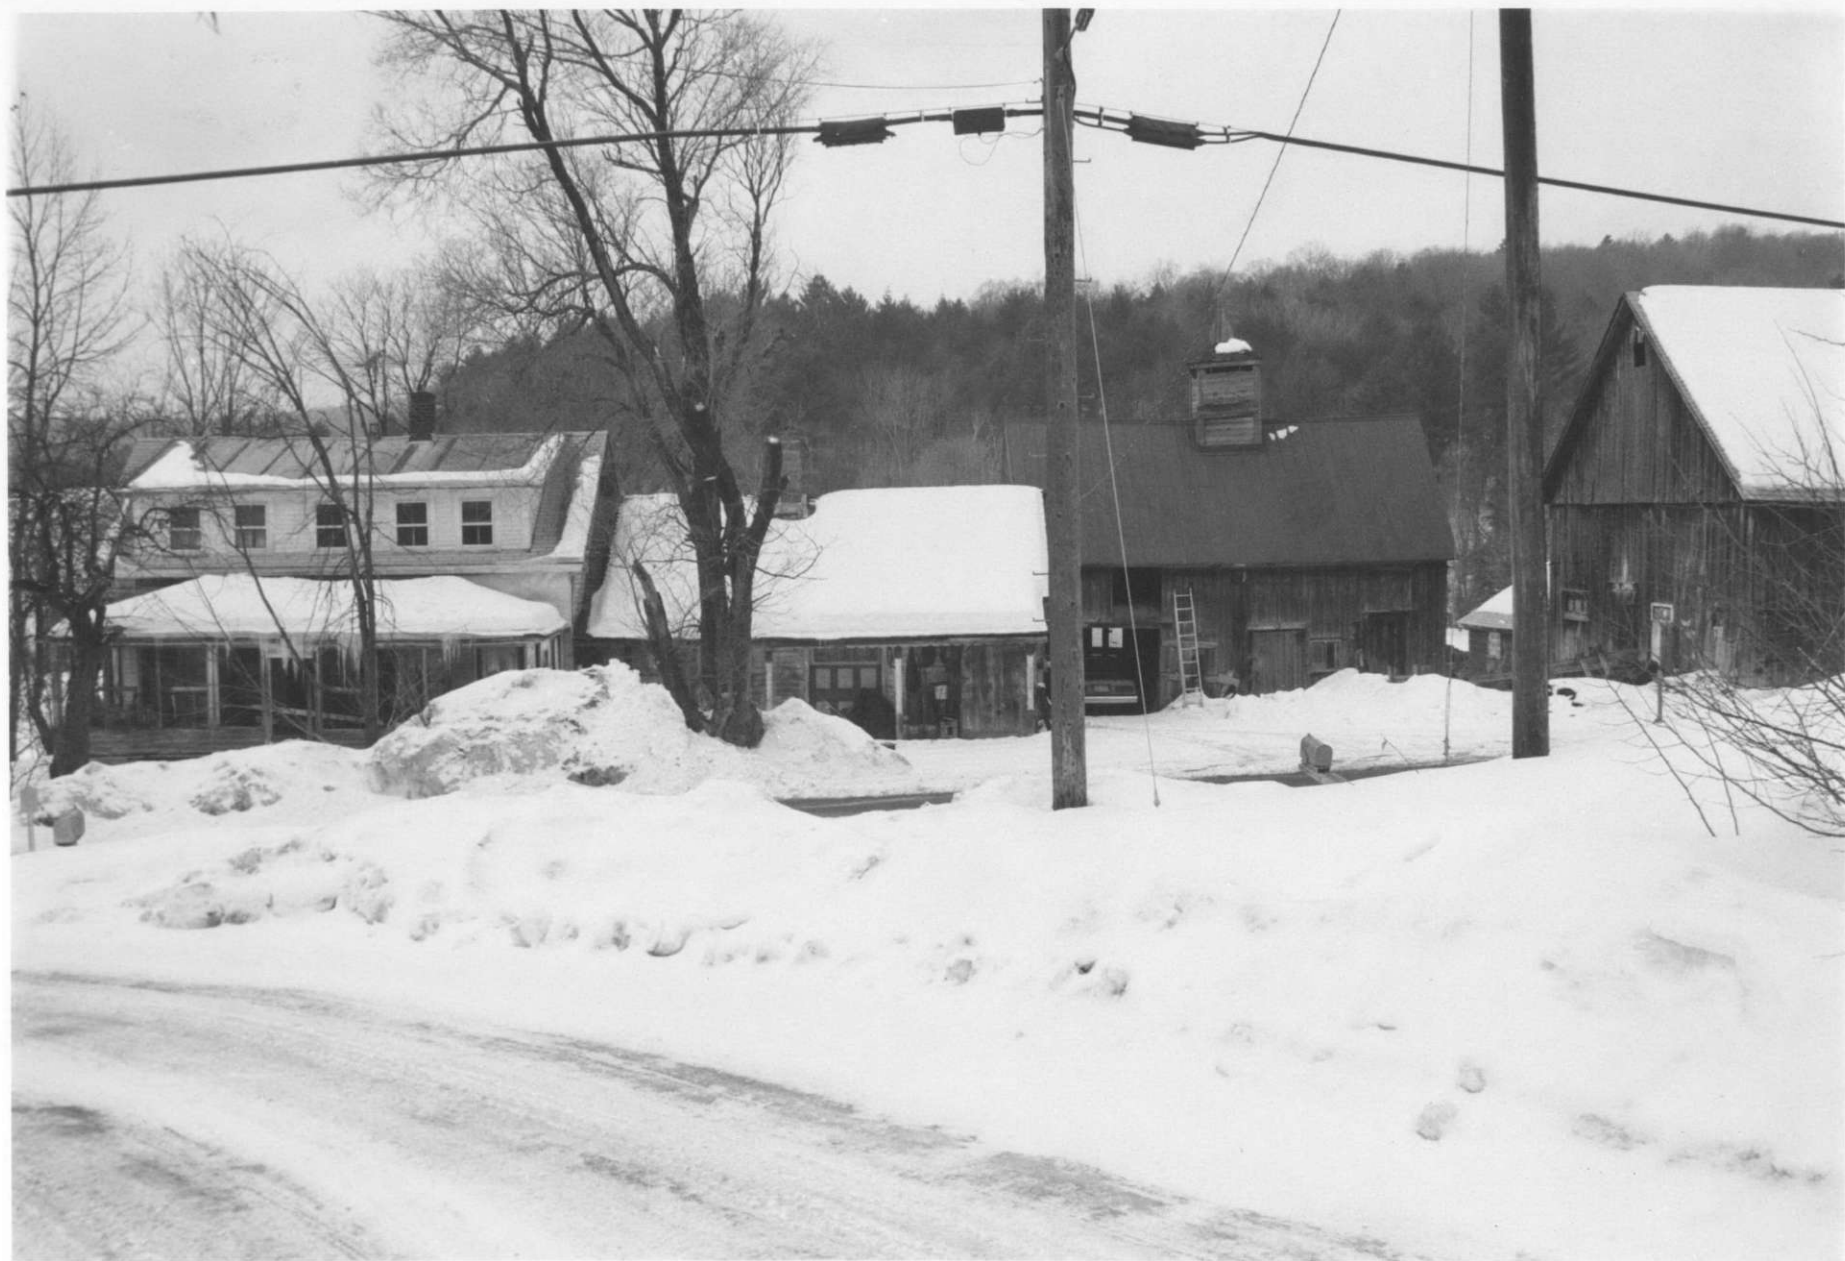
Photograph 7

#3 & 3C W

3. Donally-Perry House; c.1850.

3C. Perry Barn; c.1850 (later additions).

The Perry Barn is located five feet north of the attached house and barn, #3. It is a sprawling complex of outbuildings together forming a single barn and storage building. The main gabled bank barn is oriented along a north/south axis and has a sliding door with a glazed, multi-light transom (many panes missing) on its east facade. A concrete block, gabled projection, built in 1958, extends from the west (rear) elevation. On the north elevation of the main barn is a two-story, gabled wing; a small board and batten shed-roofed wing is attached to the wing's east facade.

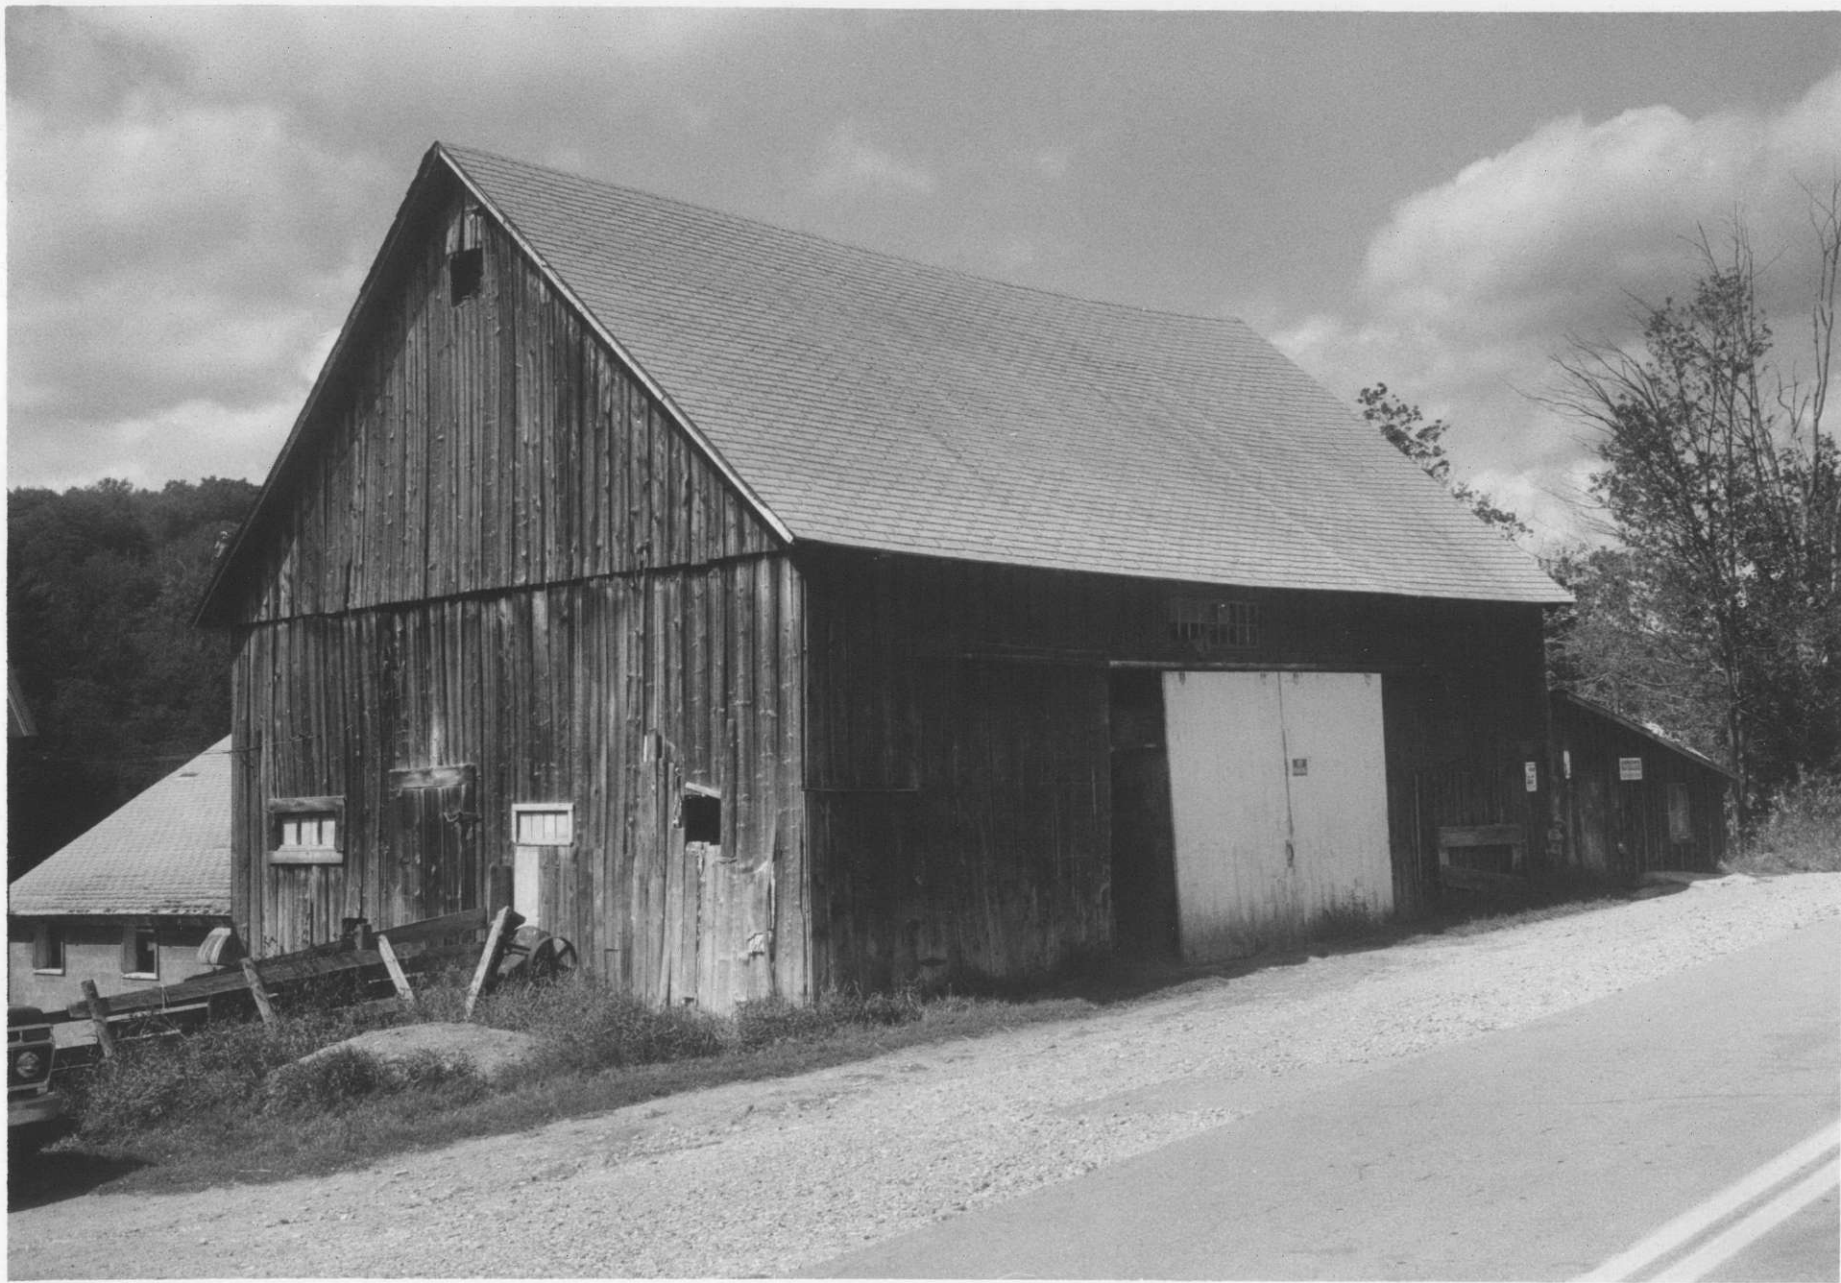
Photograph 8

#3C NW

View looking northwest.

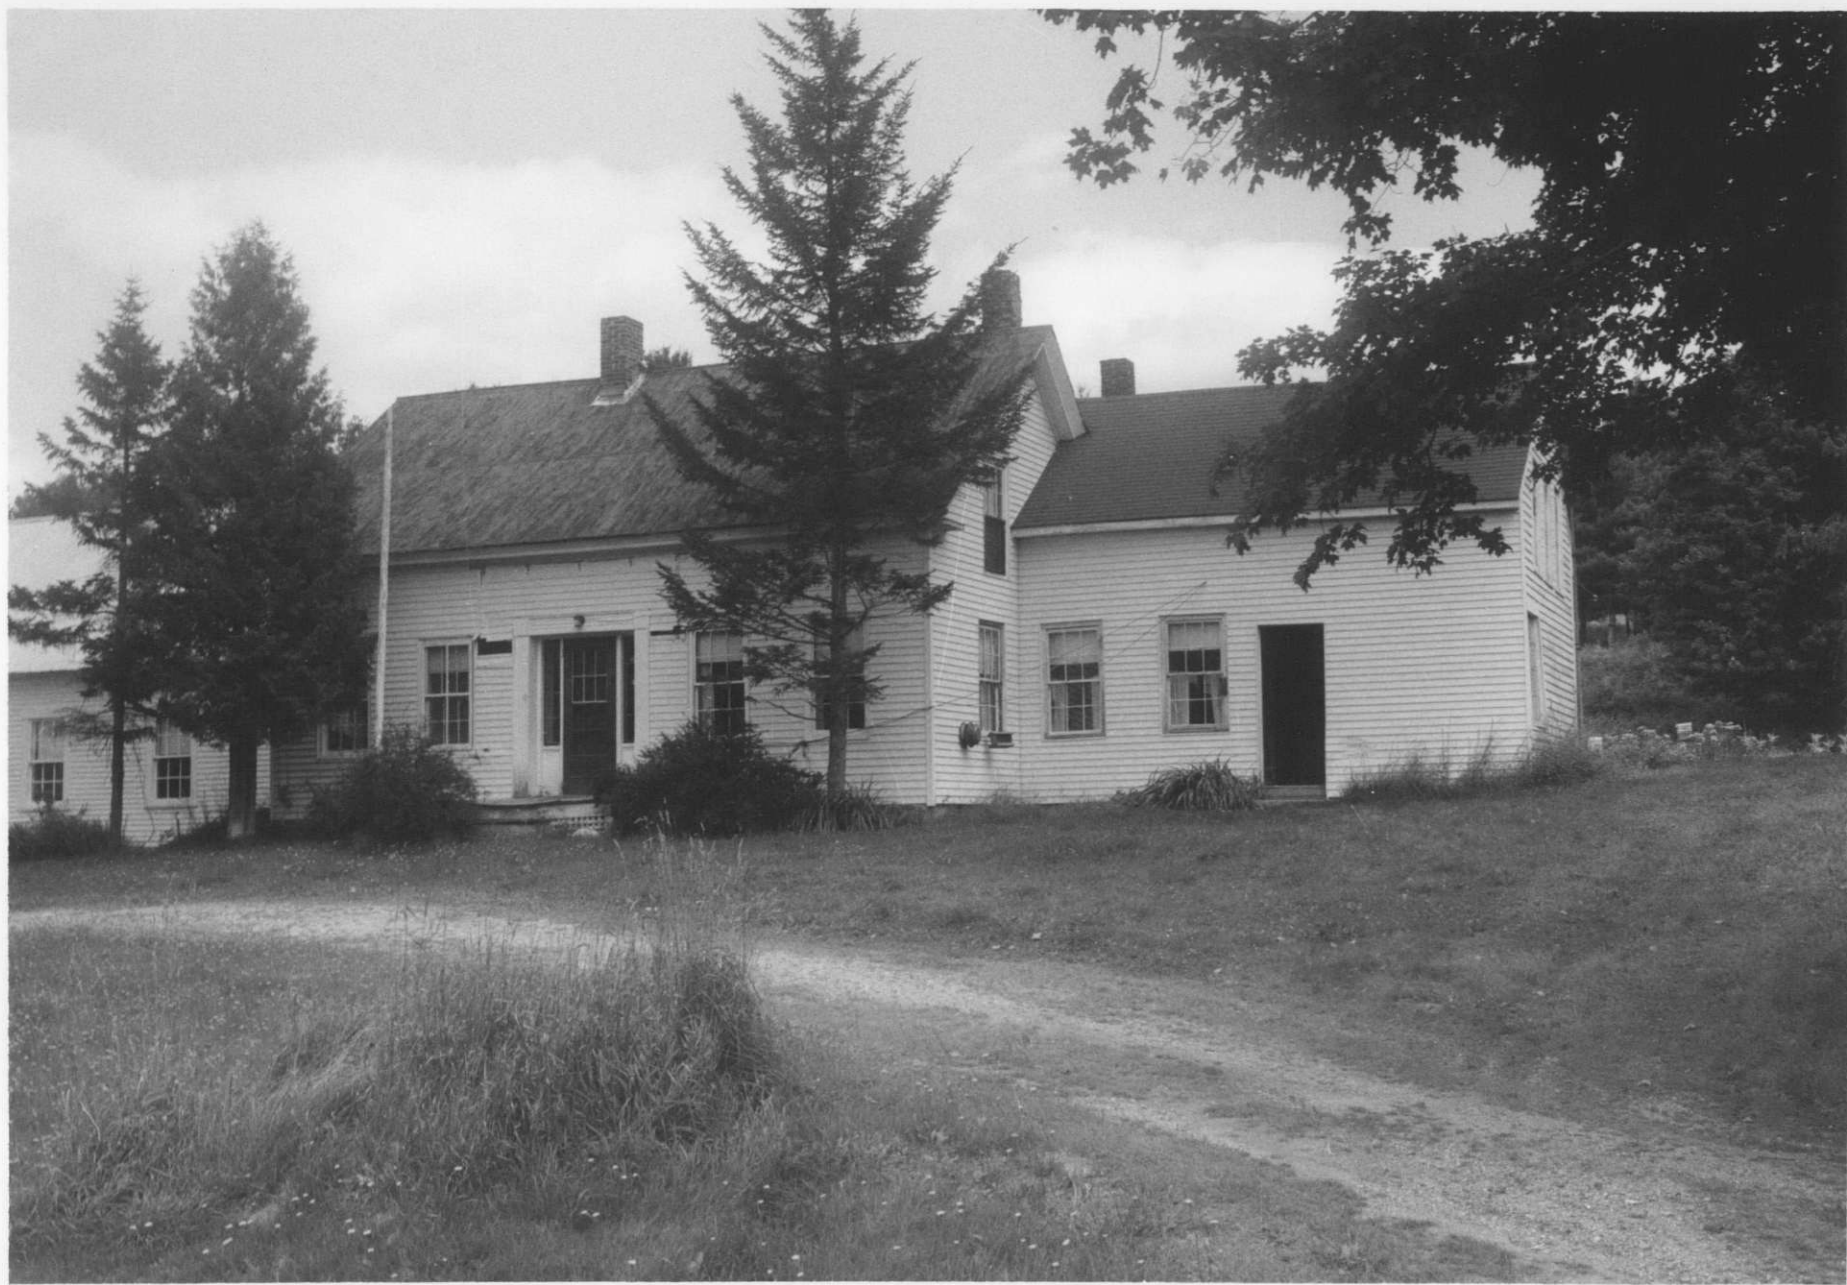
Photograph 11

#7 E

7. Old South Windham Baptist Church Parsonage (Hall House);  
c.1845.

The former parsonage of the South Windham Baptist Church, built c.1845, is now a private residence. The 5 x 2 bay, clapboarded Classic Cottage is oriented on a north/south axis, rests on a granite foundation, and has a three-bay, recessed wing extending from its south elevation. Despite aluminum siding, details include fluted door surround with corner blocks, 2/3-length sidelights, and a returning roof cornice; irregularity in the siding indicates that a porch once protected the entrance. The windows are double hung, with 6/6 sash and plain surrounds. (A modern neo-Palladian window has been placed in the south gable of the wing.) The main roof and wing roof are asphalt shingled.

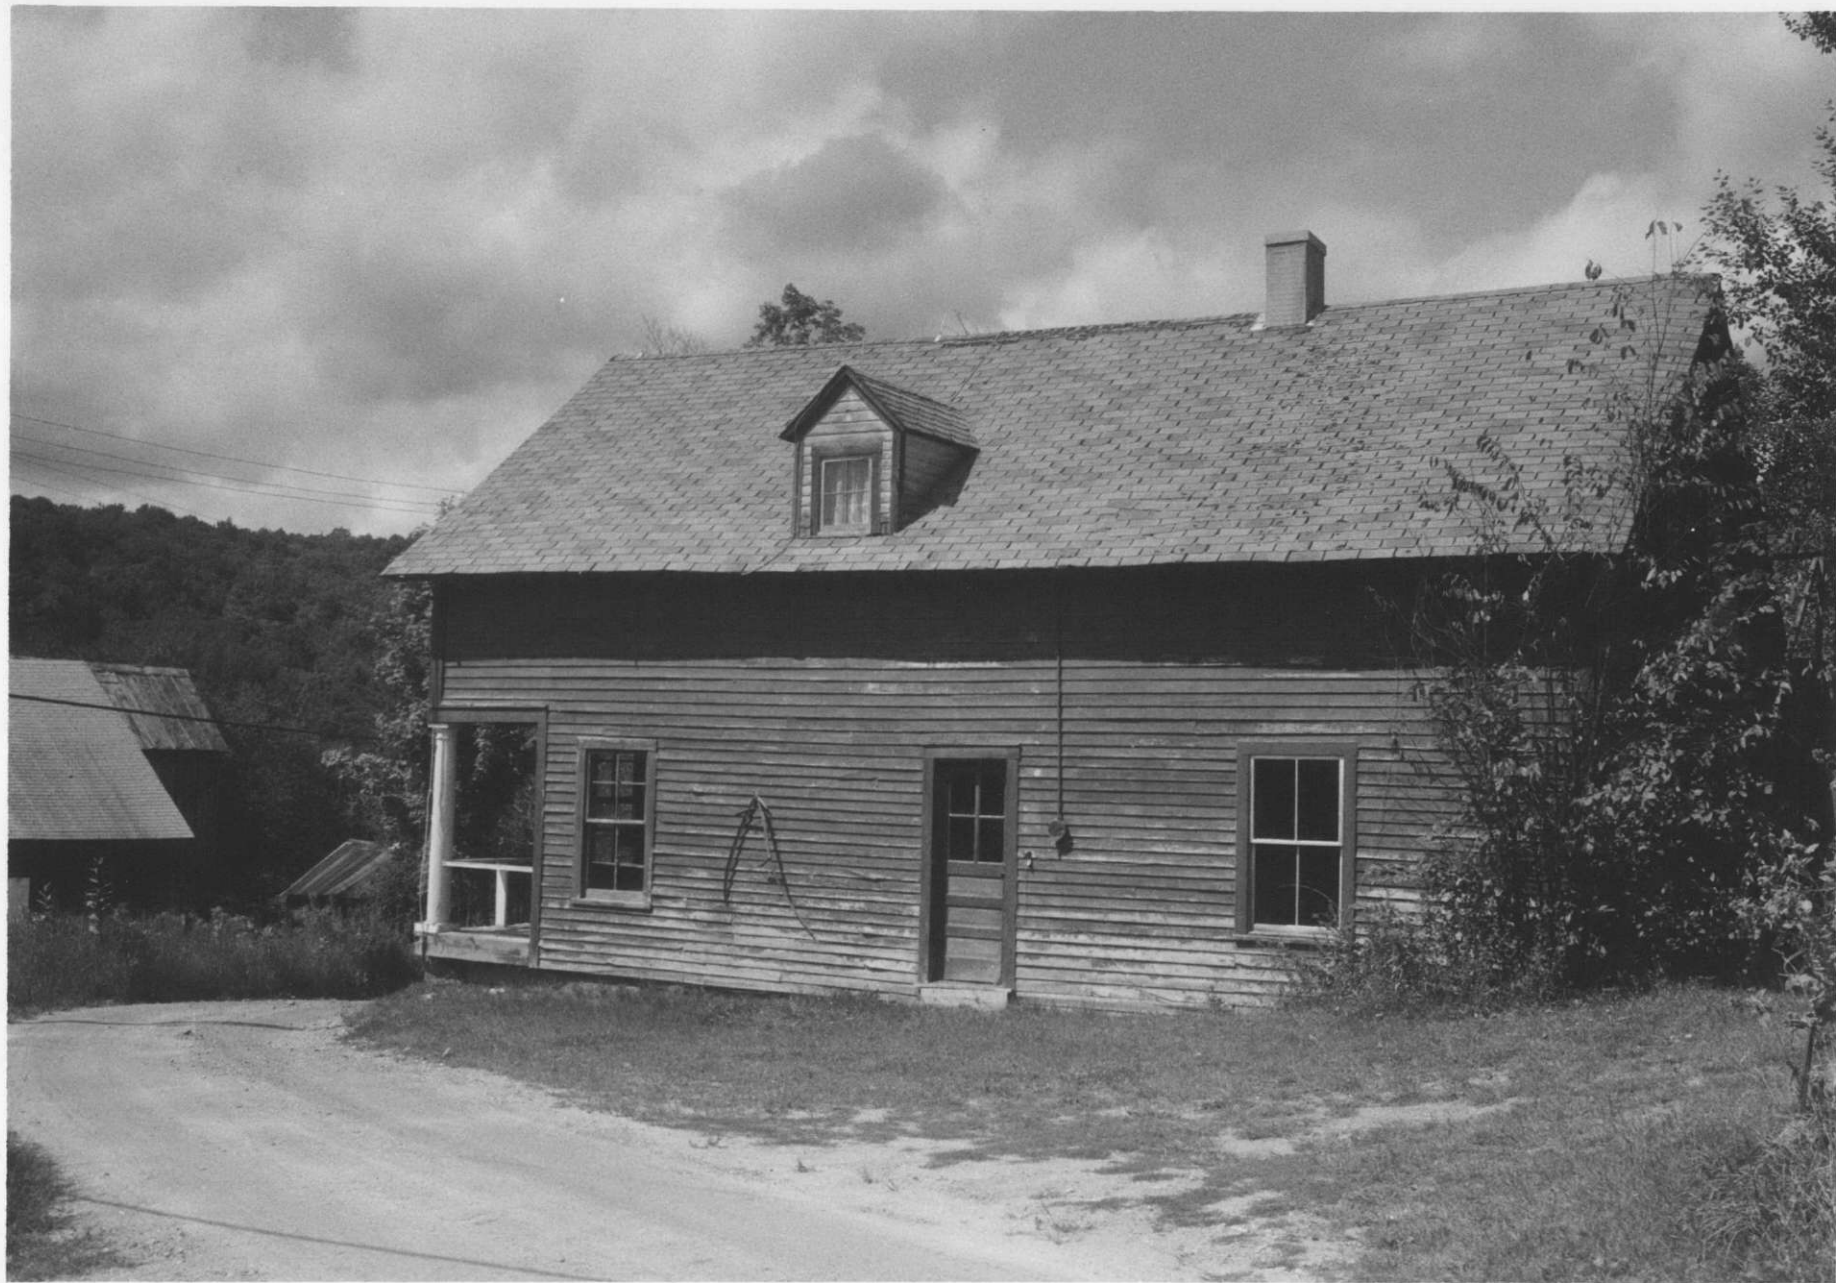
Photograph 12

#8(demolished)

8. The Old Whipple Store-Reed Property, c.1855 (Removed c.1987)

The asymmetrical, clapboarded mass of the Old Whipple Store includes a gable front, 1-1/2 story, 2 x 3 bay saltbox shape block with a front, first story recessed porch, partially enclosed with novelty board siding. Two added columns, allegedly taken from a former storekeeper's Long Island home in c.1950, support the open portion of the porch. These columns are the only stylistic references for the otherwise starkly plain vernacular building. The asphalt-shingled roof has a plain, open cornice and is punctuated by a gabled dormer on the south facade and a chimney on the ridge. Sash, with plain surrounds, include 2/2 and 4/4 windows. The store rests on a fieldstone foundation and the rear elevation includes a small shed addition and an exterior stairway that leads to the second story.

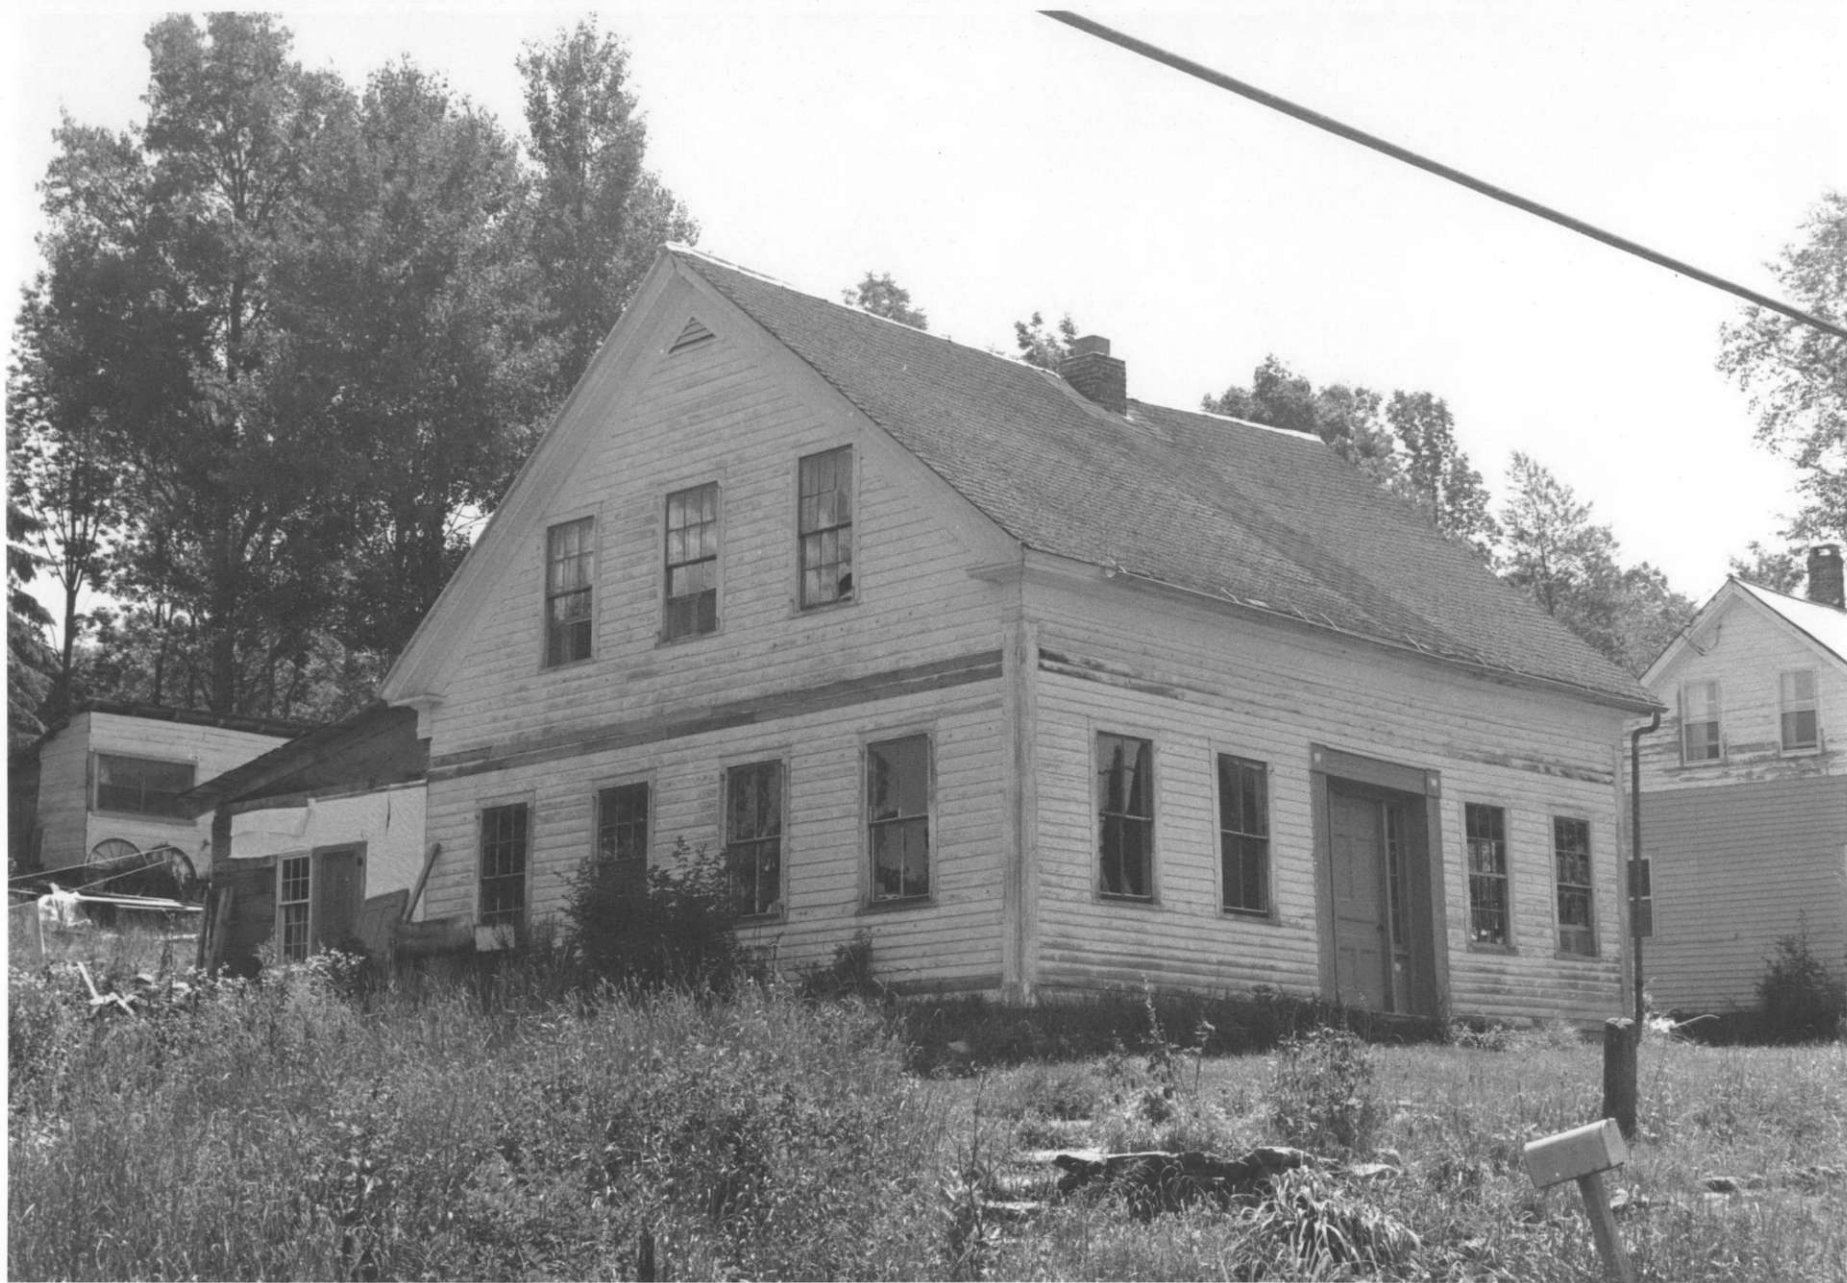
Photograph 16

#11 SE

View looking southeast.

This broadly proportioned, 5 x 4 bay, 1-1/2 story Classic Cottage of c.1840 is oriented on an approximate north/south axis. The clapboarded walls rest on a granite foundation. Details on this house include an embellished, wide frieze board, corner pilasters with fillet caps, and a returning roof cornice. The main entrance,

centrally placed on the west (front) facade, has an architrave-molded surround, corner blocks, 2/3-length sidelights, and a paneled door. The south gable end entrance has a similar surround. Windows include 6/6 and 2/2 sash. A ridge chimney projects from the asphalt-shingled roof. The house is thought to have been owned by a successful wool grower and cattle dealer during the mid-19th century. Foundation remains of a barn can be found in the back-yard. A one-story, shed-roofed rear addition is currently under construction (1988).

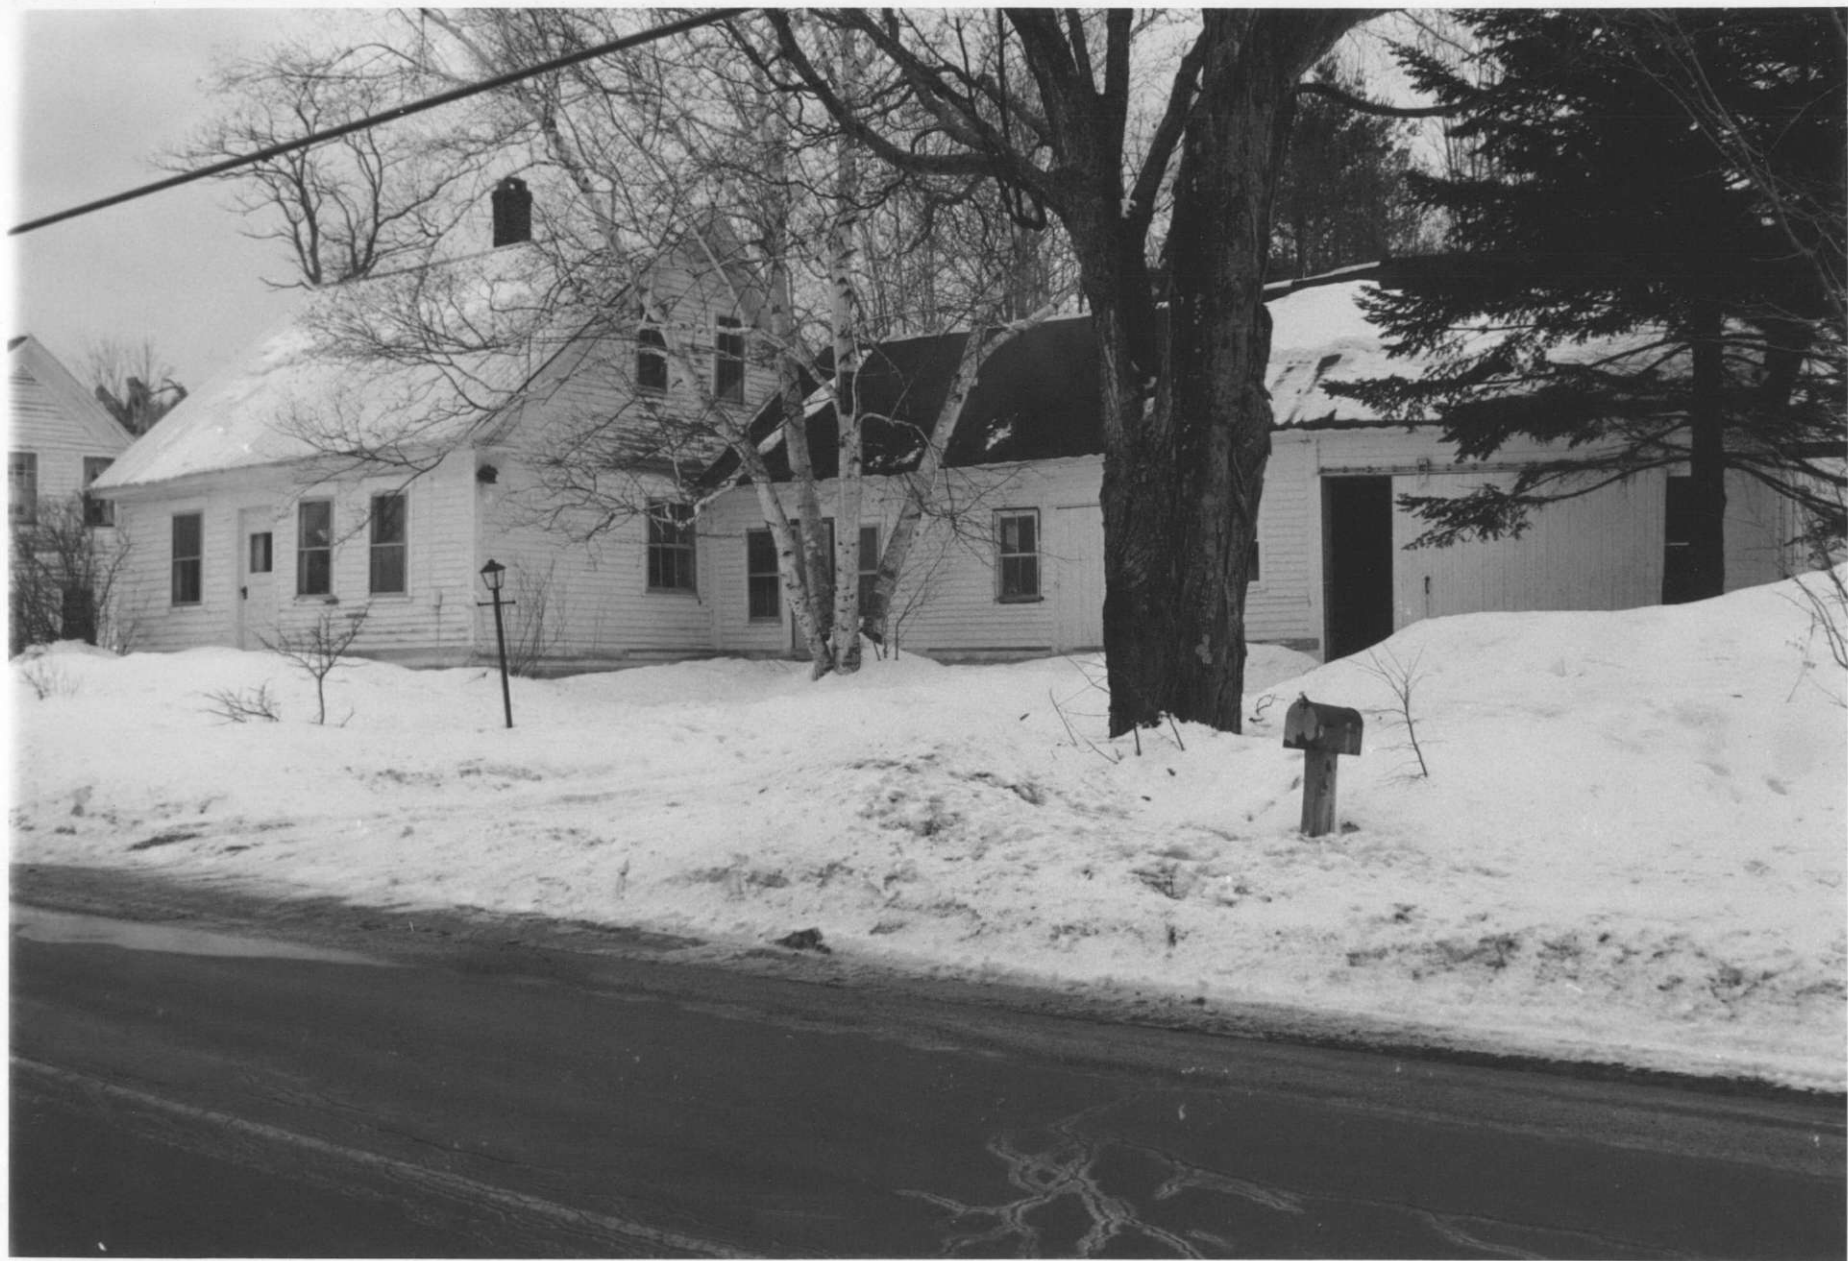
South Windham Village Historic  
District  
Windham, Vermont  
Credit: Gina Campoli  
Date: February 1984  
Negative filed at Vermont Division  
for Historic Preservation  
Description: Holmes House (#12)  
View looking east.  
Photograph 17

This 4 x 2 bay, one-story, late, 3/4 Cape type house is oriented on a north/south axis and is plainly trimmed except for cornerboards and a returning cornice. The clapboard walls rest on a granite foundation. The off-center (left) entry has a c.1910 door with toplight in a plain surround with wide lintel board. A long wing projects from the south elevation. This wing includes an entrance with flanking sidelight-like sash and two shed entrances, one with a sliding door. Both the main block of the building and the wing have central chimneys located on the ridges of their respective metal roofs. The double-hung sash windows have 2/2 and 1/1 glazing patterns in plain surrounds with wide lintel boards. Most of the windows are covered with aluminum storm windows. Nineteenth century owners included A. Smith, a postmaster, shoemaker and farmer.
